Innovative solution to diagnosis and prognosis of defects and failures in cast-resin transformers for sustainable assets and risk management

An innovative electronic device for on-site and on-line monitoring of cast-resin transformers was designed and constructed after four years of lab tests in 2017

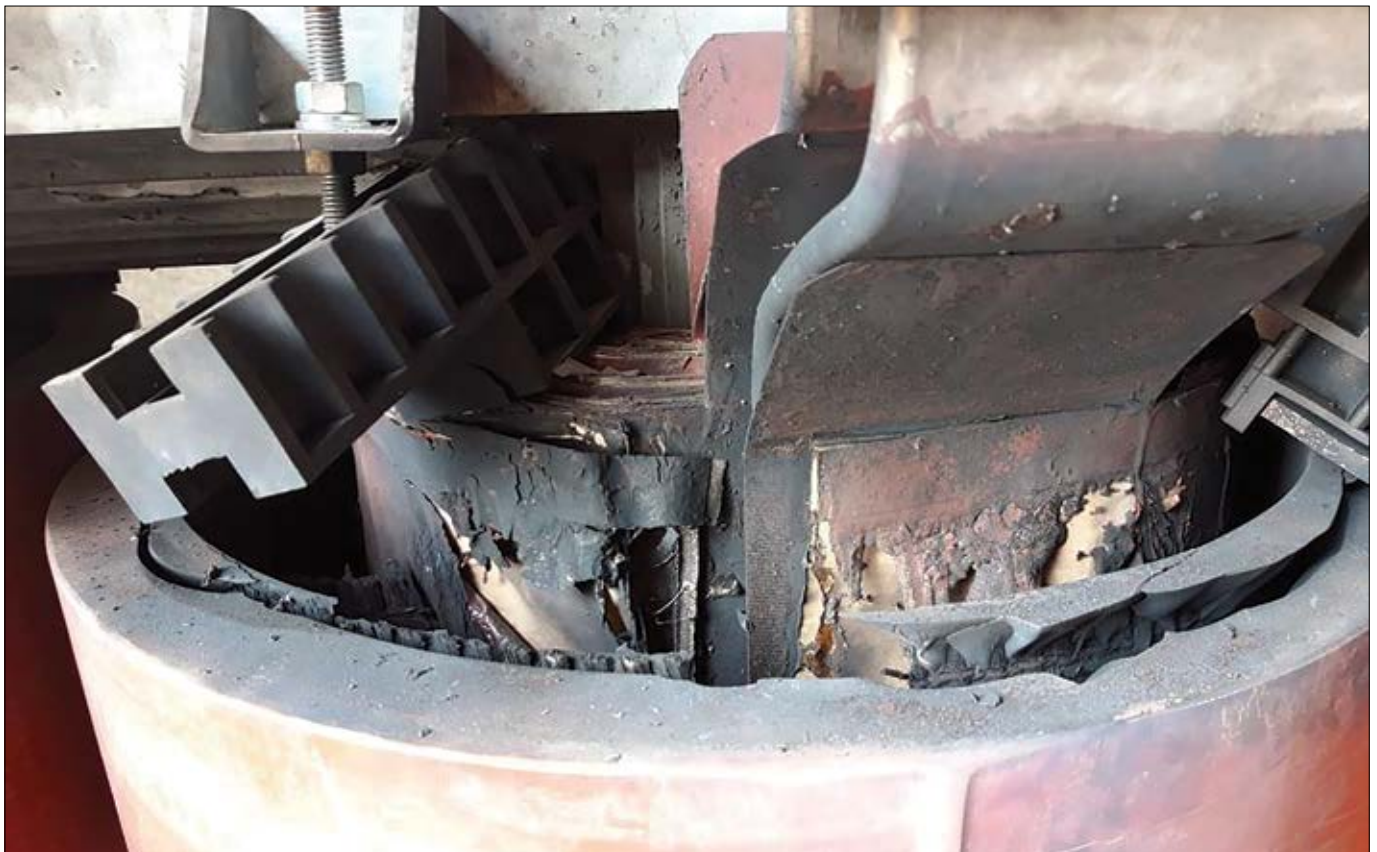
One of the nine monitored transformers (#6 in Table 2) experienced particularly severe damage that led to failure.

During the experimental campaign, fatal damage occurred in one transformer (#6 in Table 2). A second transformer (#7) was plagued by faulty components: the sealing end of the secondary cables (not on the machine itself) either because of prolonged overheating or arcing (according to the owner). The latter could be brought to light by the sensors (ozone, mainly).

The ozone profile is displayed in Fig. 5. Ozone can be produced by electric and corona discharges [15], whose occurrence is proven by the clear signs of catastrophic discharges in Fig. 4. The overall signal spectrum and a closeup at the time of failure are shown. The highest concentration of ozone, 326 $\mu\text{l/l}$ (ppm), was detected at the instant of breakdown (see expanded graph where the highest peak is shown). However, it is also interesting to point out that a few hours earlier, a couple of smaller peaks were detected at a normalized value of around 0.1. This was a special case with a disastrous event where the formation of ozone was certainly due to powerful arcing. Obviously, using the maximum value is not practical for real-time monitoring. However, through a *posteriori* analysis, it can be determined if small peaks had meaning or were just noise. In fact, considering that the standard deviation

Fig. 4. The destructive effect of an electrical fault. Catastrophic discharge destroyed the central phase and charred part of the resin. The VOC sensor positioned above the phase was hit by the blow and failed.

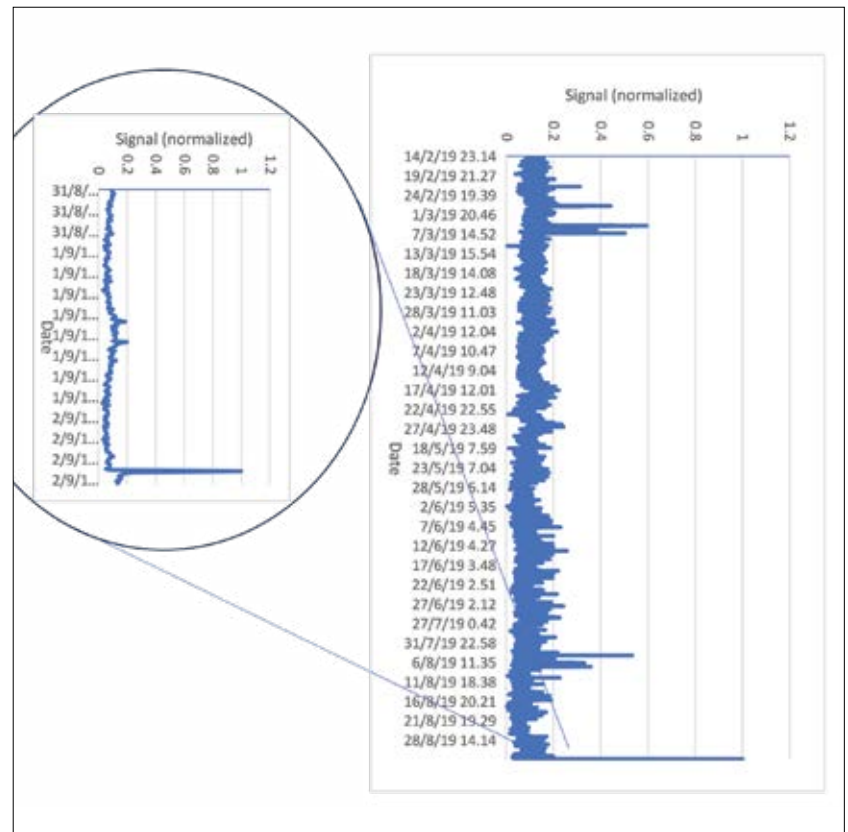
is 0.039, one could be inclined to regard those spikes as a sign of ozone formation. However, a broadened observation reveals that 0.11 is the most recurrent and thus probable value (mode), which weakens the strength of the previous proposition and strengthens the assumption of that value being either noise or interference. (The latter is from NO₂ exclusively. Nitric oxide is the principal interfering molecule of ozone detection, as stated in the sensor's datasheet.) On the contrary, the source of other peaks exceeding 0.3 could be associated with ozone formation. This implies that discharge-related incidents might have occurred in previous months, even though a massive presence of NO₂ cannot be excluded. A comparable piece of information is provided by a device installed next to another transformer (#8 in Table 2) for which the value of the mode is 0.08, quite close to the 0.11 value reported above.

Fig. 5. Ozone profile from the failed transformer: on the ordinate the normalized concentration value, on the abscissa the date of sampling. The arrow points at the moment of failure.

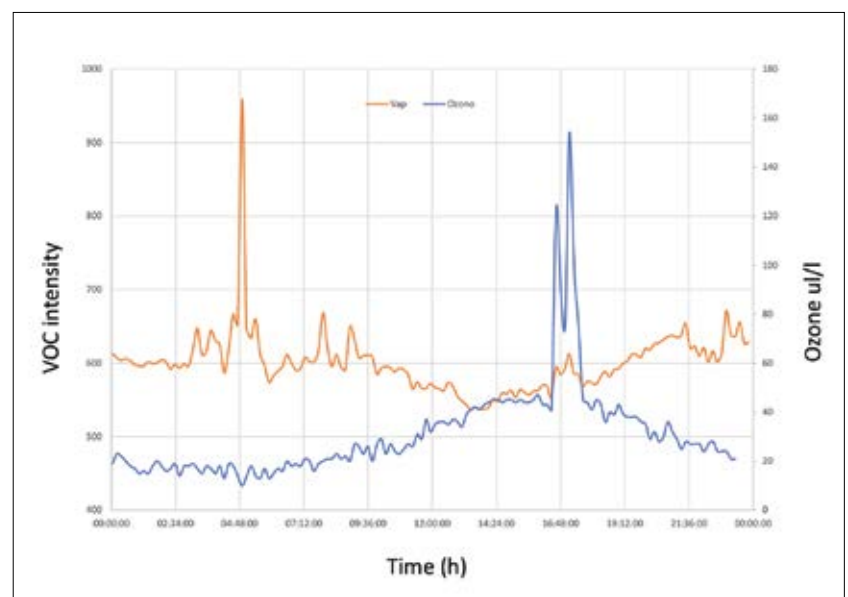
Monitoring of the second transformer, which suffered damage (#7 in Table 2), reveals the formation of ozone gas (maximum value 181µl/l). The spotting of high ozone concentration triggered an alert and a consequent on-site verification where a problem was discovered, as mentioned above. In fact, the technicians found that the cable sealing ends on the low-voltage side were loose and partially burnt, possibly due to overheating or arcing. Figure 6 displays an ozone peak at 16:48 (blue curve) and a VOC peak at 4:48 a.m.

Fig. 6. Ozone profile (blue line) and VOC profile (orange line) from the damaged transformer on the day of the alert. Ozone concentration and VOC intensity are shown on the ordinate and time on the abscissa.

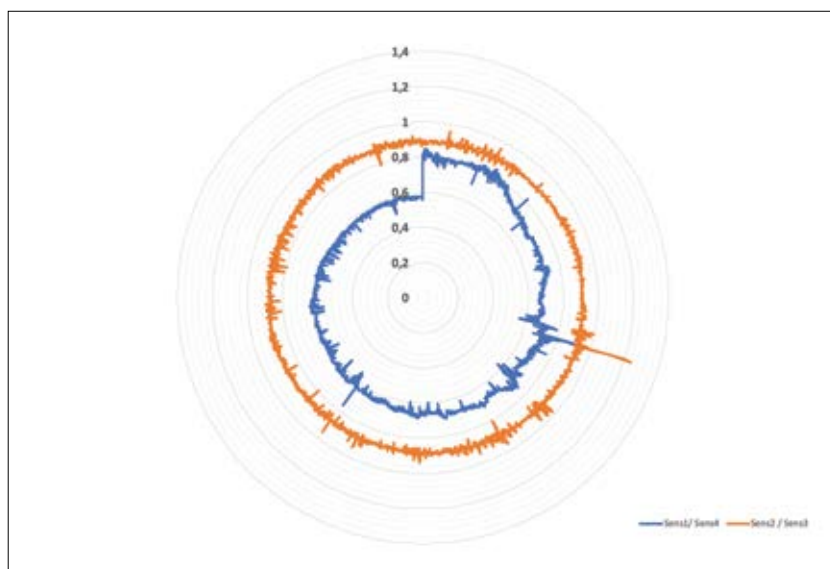
Figure 9 shows a radar chart that displays the same ratios as Fig. 8, but for transformer #7 (the one that suffered damage to its sealing ends). Here again, the signal ratios oscillate inside a given annulus and exhibit a peak at a given time unmistakably associated with the presence of organic molecules, either from the transformer or from outside the room.

Fig. 9. Ratios between signals of a 4-MOS cluster for transformer #7. The inner curve is the ratio between sensor 4 and sensor 1 (abbreviated as the reciprocal), and the outer curve is the ratio between sensors 3 and 2 (abbreviated as the reciprocal).

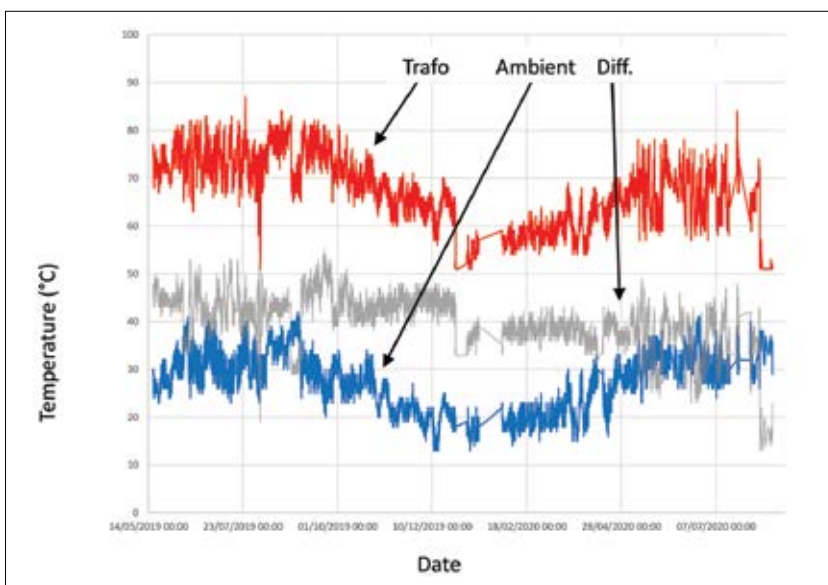
Regarding the transformer which suffered a destructive failure, the difference between the environmental temperature and the maximum superficial temperature measured on the side "seen" by the thermal camera is shown in Fig. 10. Such difference oscillated between 40°C and 50°C on average, which is far below the acceptable maximum overtemperature (100°C), as declared by the manufacturer. Obviously, the internal temperature was higher, and the presence of hot spots could not be excluded.

Fig. 10. Difference in temperature between the room environment and the transformer.

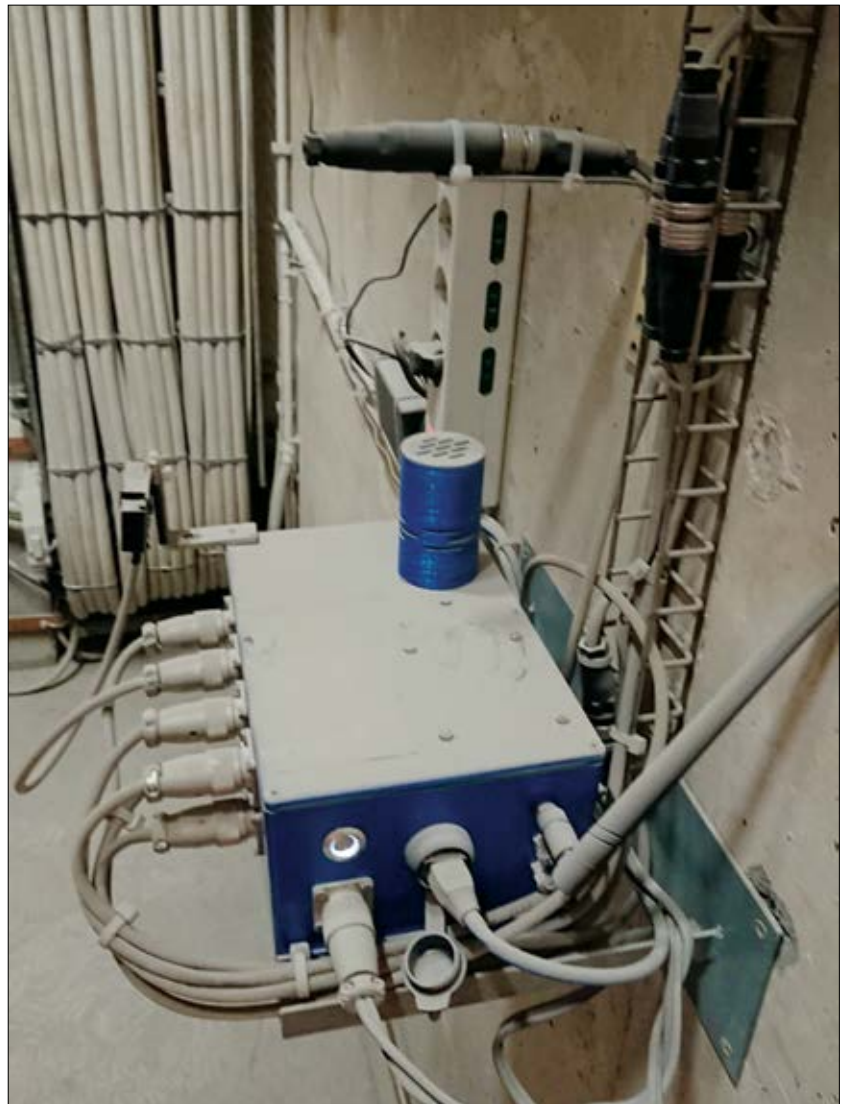
Fig. 11. Data acquisition device after a few months in a dirty room.
