Innovative solution to diagnosis and prognosis of defects and failures in cast-resin transformers for sustainable assets and risk management

An innovative electronic device for on-site and on-line monitoring of cast-resin transformers was designed and constructed after four years of lab tests in 2017

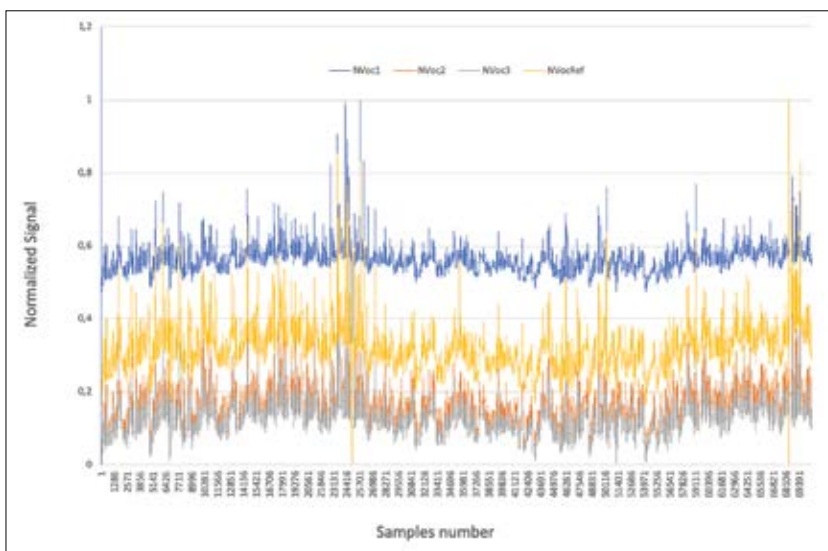
Fig. 7. Normalized signals of four equivalent MOS sensors

In Fig. 7 a comparison of signals from four equivalent MOS sensors positioned in different places is shown. Regardless of placement right above a phase, at a certain distance, or even outside the room, information is the same. It follows that the air inside and outside the room is similar and marked by a high level of external pollution, which is recognized to contribute to failures as it can create carbon deposits on accessible parts and lead to tracking and potential failure [14]. Consequently, sensors that monitor contamination levels are useful and necessary.

In Fig. 7 sensors 1-3 were placed one at each phase of transformer #2 (see Table 2). The fourth is the external reference positioned in different places inside the room. The profiles do not vary from curve to curve, and only the relative intensities are different. Normalization was performed according to the following calculation: (average – min)/(max-min). This was a posteriori signal analysis, which cannot be employed in real-time.

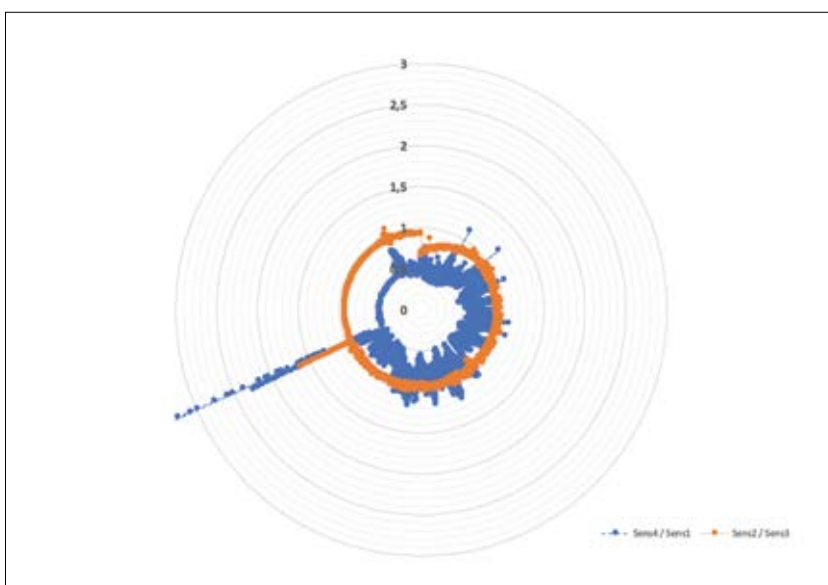
Fig. 8. Ratios between signals of a 4-MOS cluster for transformer #2 (see Table 2). The inner curve is the ratio between sensor 4 and sensor 1 (abbreviated as the reciprocal), and the outer curve is the ratio between sensors 3 and 2 (abbreviated as the reciprocal).

but when sensors are exposed to chemicals, a spike appears. The peak of the ratio between sensor 3 and sensor 2 is less prominent because of an almost exclusive responsiveness to aliphatic and aromatic hydrocarbons.
